# DRAFT BIOLOGICAL ASSESSMENT FOR THE RUSTY PATCHED BUMBLE BEE

for Midfield Cargo Development

**Chicago Rockford International Airport**

**April 2022**

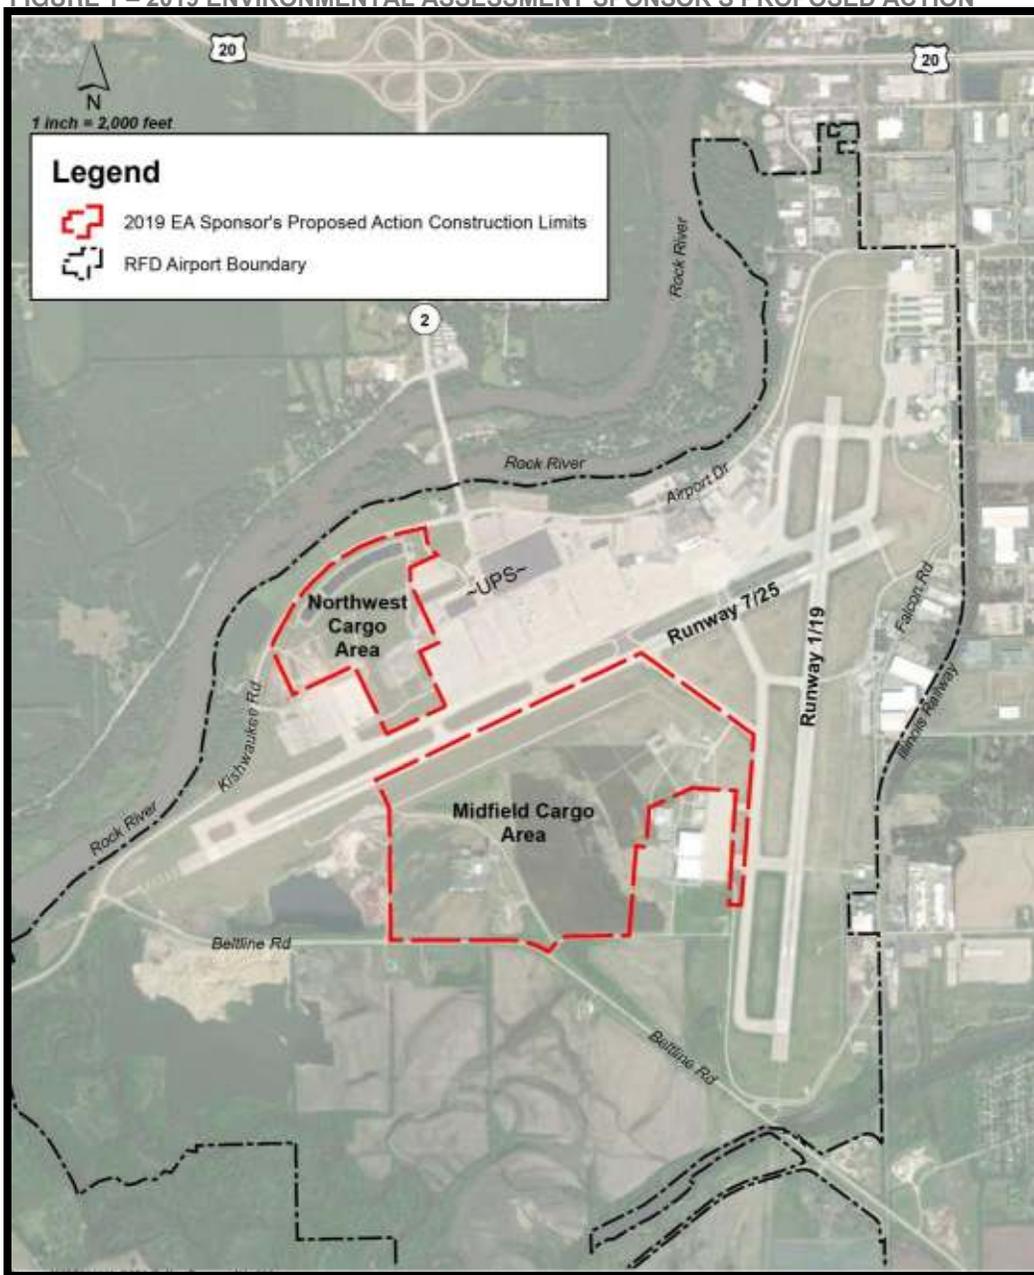
FIGURE 1 – 2019 ENVIRONMENTAL ASSESSMENT SPONSOR'S PROPOSED ACTION

The Rockford International Airport (RFD) is located in northern Illinois in the southern part of Winnebago County (Township 43N, Range 1E, Section 22). RFD encompasses over 3,000 acres and is generally bound by Illinois State Route 251 to the east, the Kishwaukee River to the south, the Rock River to the west, and U.S. 20 to the north. The Sponsor's Proposed Action, as approved in a 2019 Environmental Assessment, included development of the Midfield Cargo Area, located south of Runway 7/25, west of Runway 1/19, and north of Cessna Drive and Beltline Road, and development of the Northwest Air Cargo Area located north of Runway 7/25, shown on Figure 1.

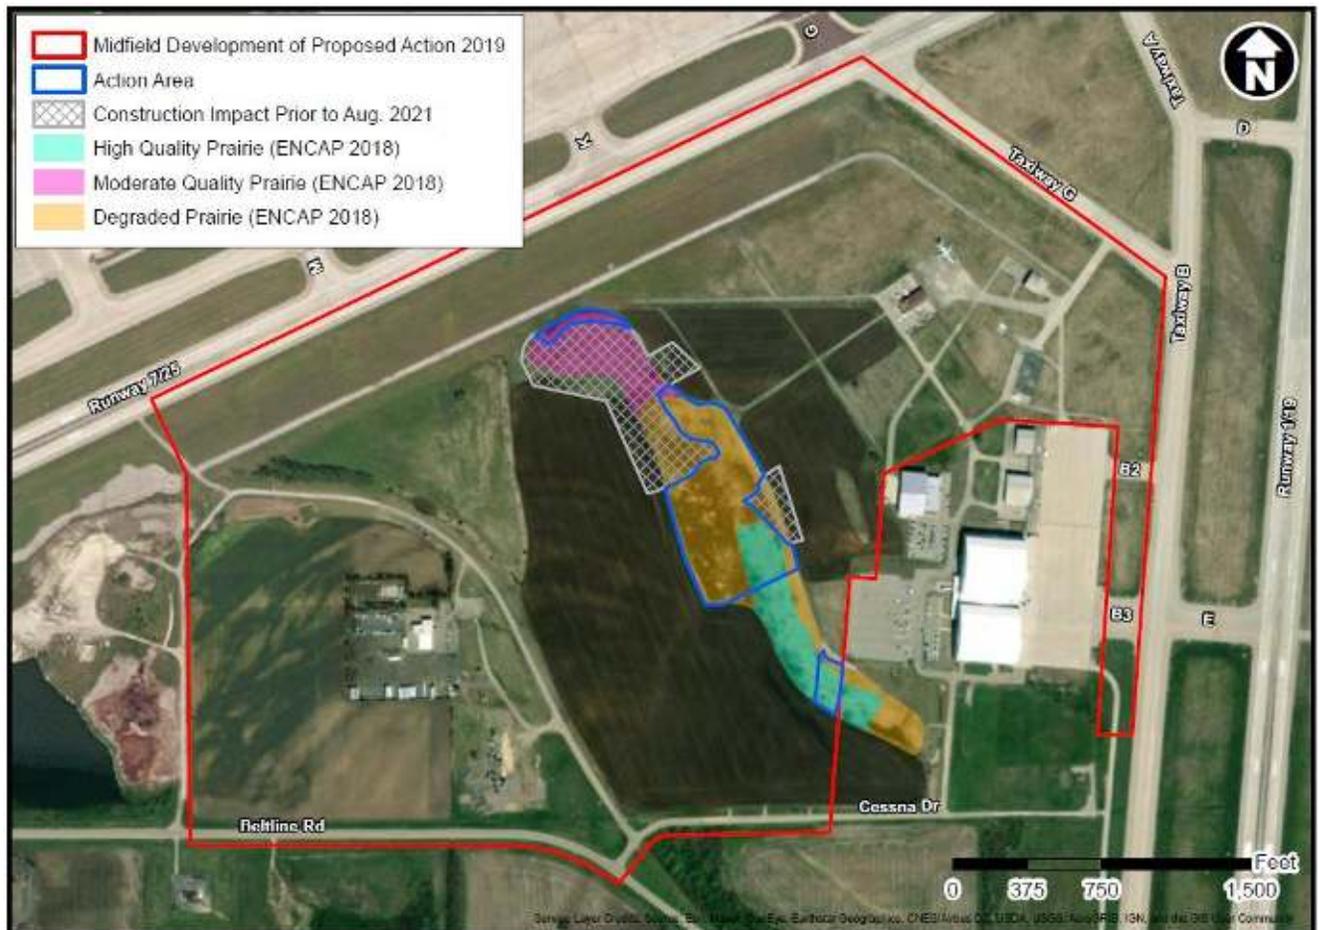
FIGURE 2 – ACTION AREA

The Action Area is a project area applicable to consultation under the Endangered Species Act. It is defined as all areas to be affected directly or indirectly by the FAA action and not merely the immediate area involved in the action (see 50 CFR § 402.02). The Action Area includes the proposed remaining development area within the prairie boundary in the Midfield Cargo Area part of the Sponsor's Proposed Action (Action), as shown in Figure 2.

While the Northwest Air Cargo area and the non-prairie areas of the Midfield Cargo Area are part of the development area for the Sponsor's Proposed Action, these areas were either disturbed or routinely mowed before and/or after construction was approved in the 2019 Environmental Assessment and Finding of No Significant Impact (FAA, 2019) and do not contain habitat for any documented listed species. A portion of the prairie was already impacted by approved construction prior to August 2021, when construction was halted to reinstate agency consultation, described further in Section 1.3. Therefore, these areas of prior disturbance and lack of habitat are not included in the Action Area for this Biological Assessment. Photos of the remaining prairie habitat are provided in Appendix B.

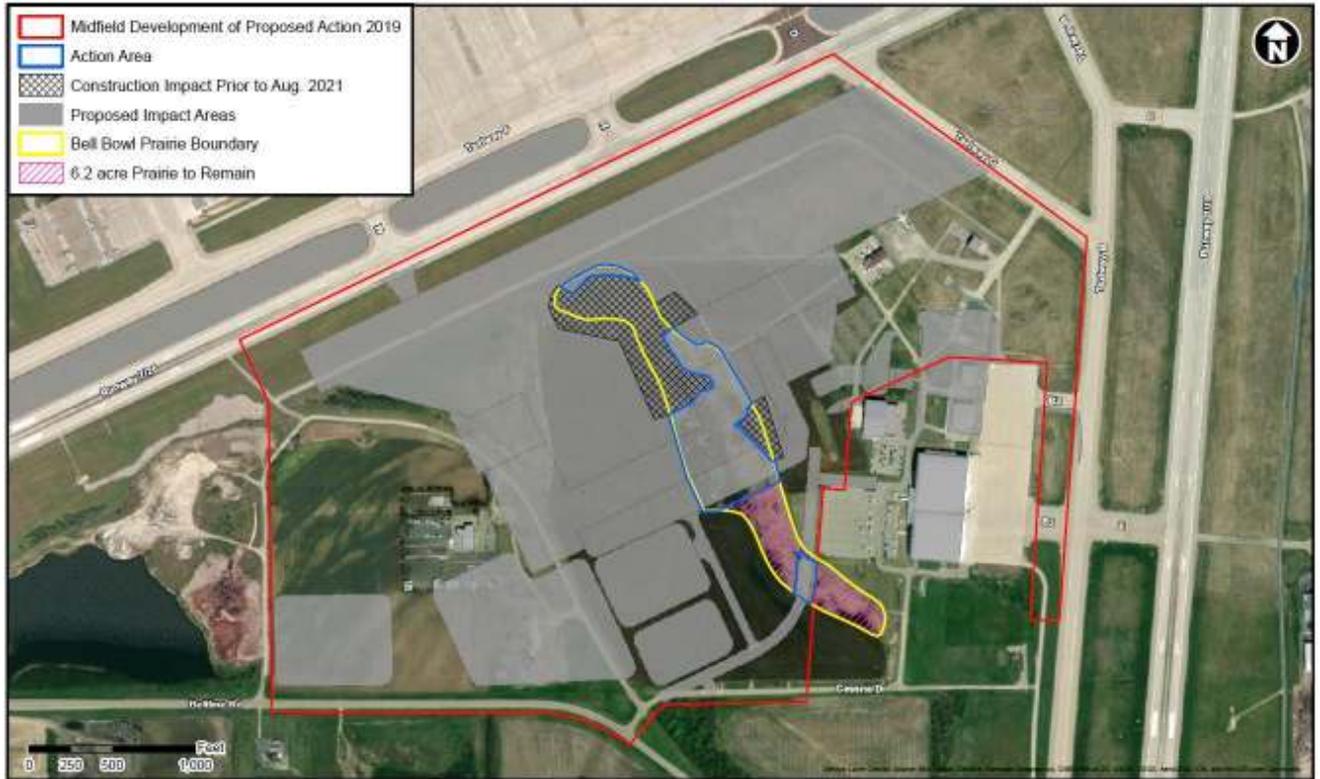
FIGURE 3 –ACTION EXHIBIT

As noted in the 2019 EA, no wetlands or other regulated surface waters will be impacted by the project. A portion of the Action Area is located within the 100-year floodplain of the Kishwaukee River. A Master Drainage Study was completed and included a proposed conditions hydraulic analysis to evaluate the floodplain and floodway boundaries based on the proposed development conditions and to determine the potential change in upstream or downstream flooding. As an outcome of the Master Drainage Study, the Federal Emergency Management Administration (FEMA) issued a Conditional Letter of Map Revision (CLOMR) for the proposed project, including a change in the floodplain boundary. A copy of the CLOMR and associated correspondence can be found in the Final Environmental Assessment (FAA 2019) for the project.

After approval of the 2019 Environmental Assessment, construction of the project began in Fall 2020. Approximately 6.2 acres (2.6 acres degraded, 3.6 acres moderate and 0 acre high quality) of the prairie was disturbed prior to August 2021 for grading and excavation of detention basins and other air cargo facility infrastructure associated with the Action.

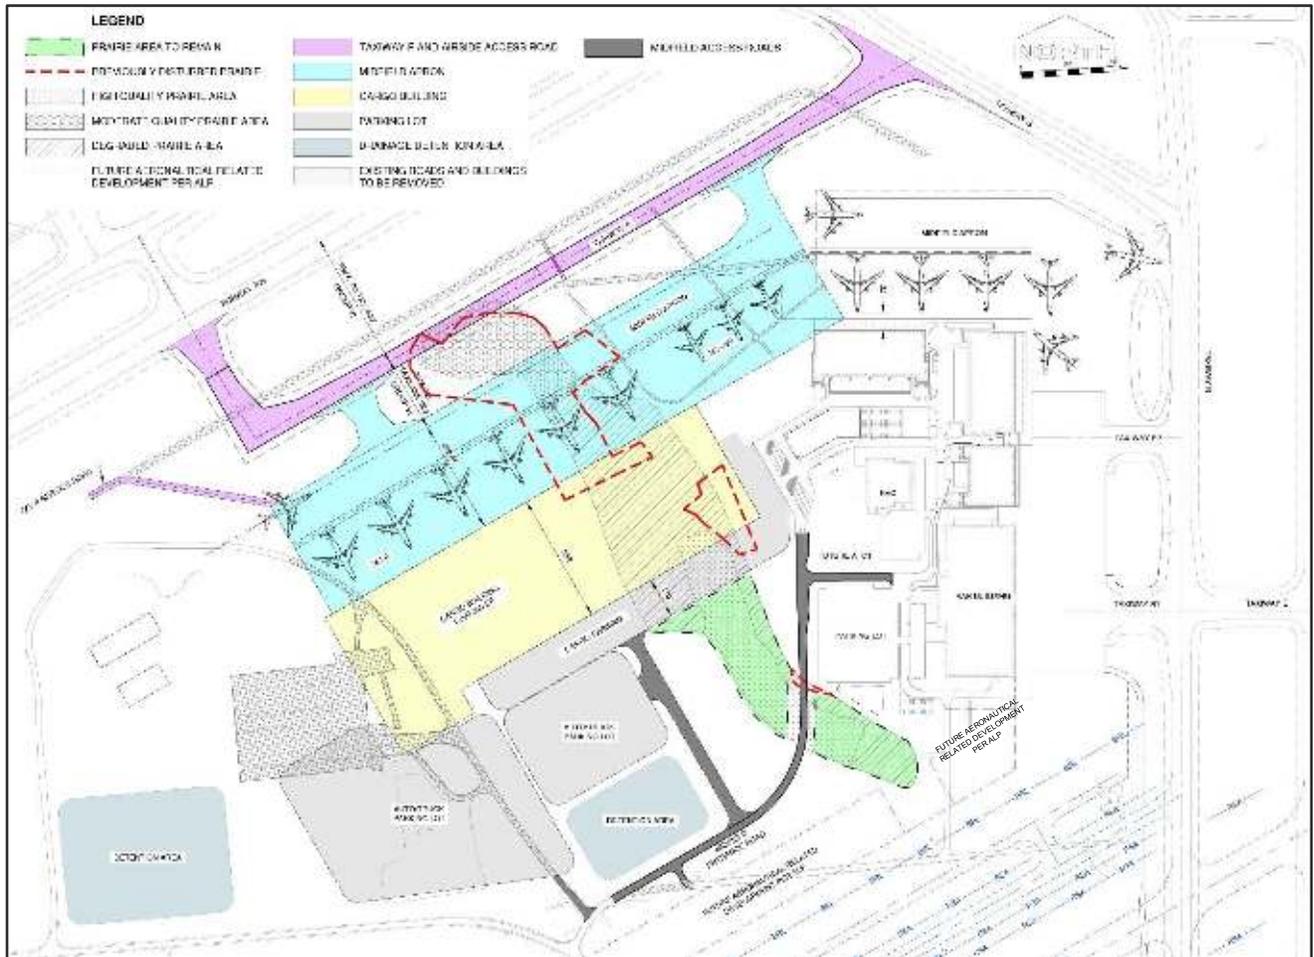
**FIGURE 5 –ALTERNATIVE 2: ACTION (PREFERRED ALTERNATIVE)**

This alternative provides the following benefits over the other identified alternatives:

- Meets the purpose and need by providing the airfield and landside improvements that would accommodate the forecast air cargo operations
- Safer roadway alignment than Alternatives 3, 4 and 5
- Reduces the impact on the prairie habitat due to the removal of the stormwater detention basin that was planned under Alternative 1

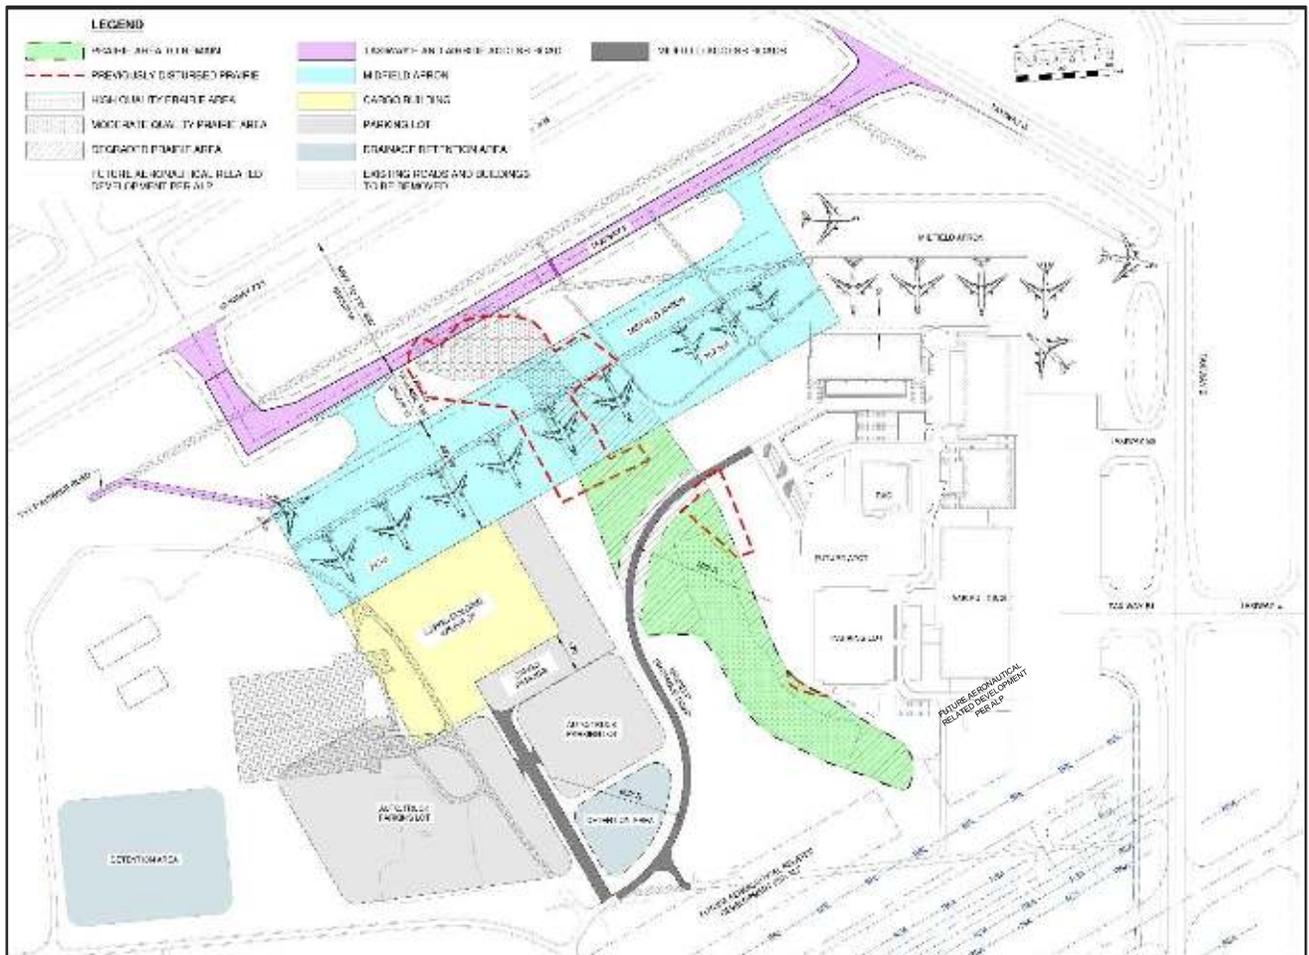
FIGURE 6 – ALTERNATIVE 3: NORTHERN ACCESS ROAD ALIGNMENT

This alternative would result in a total impact of 3.6 acres of prairie remaining after August 2021 (2.9 acres degraded, 0.7 acre moderate and 0 acre high quality) and would include the retention of 11.8 acres of prairie, including 5.2 acres of high quality prairie and 6.6 acres of degraded prairie. This alternative would not meet the purpose and need due to the reduced building volume, and therefore was not selected.

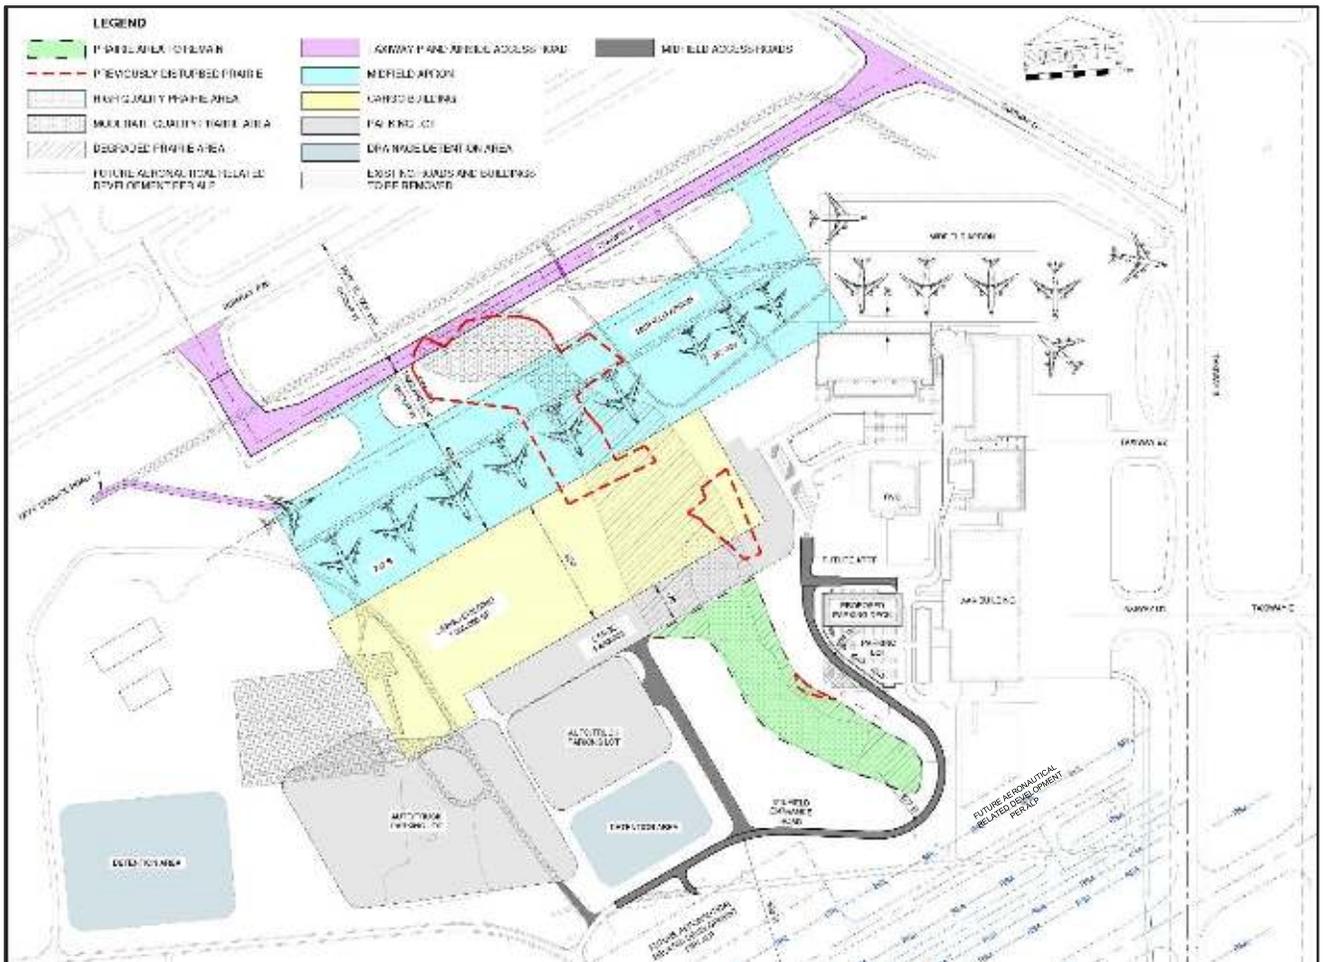
FIGURE 7 – ALTERNATIVE 4: EASTERN ACCESS ROAD ALIGNMENT

Alternative 4 includes a new midfield access road from the existing Cessna Drive with a curve to the eastern edge of the existing prairie area. This alternative provides a less efficient access to the Midfield Cargo Development area. The alignment requires a series of reverse curves, starting with a 600' radius curve, followed by a 361' tangent section leading into a 273' radius curve, exiting to a 366' tangent section into 408' radius curve to avoid the prairie on the east end. The central curve of 273' is at the minimum radii and the alignment requires the use of maximum superelevation to accommodate the geometric alignment. The IDOT BLRS Design Manual recommends avoidance of minimum radii and maximum superelevation especially in areas subject to ice and snow. The City of Rockford, Illinois averages 35 inches of snow per year.

The addition of curves in the road results in a less safe roadway compared to the Action. The safety performance evaluated using IHSDM indicated that this roadway alignment would be expected to result in approximately 14 crashes within the 20 year design horizon (see Appendix D).

This alternative would also impact the existing utilities, including watermain, ComEd electric and Nicor gas, the existing detention basin located south of the MRO building and approximately 100 spaces currently serving the existing MRO facility.

This alternative would impact 8.7 acres of prairie remaining after August 2021 (1.1 acres of high quality, 0.7 acre moderate and 6.9 acres degraded prairie) and would include the retention of 6.7 acres of prairie, including 4 acres of high quality prairie and 2.7 acres of degraded prairie.

This alternative meets the purpose and need. Due to the decreased safety performance of the roadway and the use of the minimum radii and maximum superelevation, which are not recommended by the IDOT BLRS Design Manual, this alternative is not prudent and was not selected.

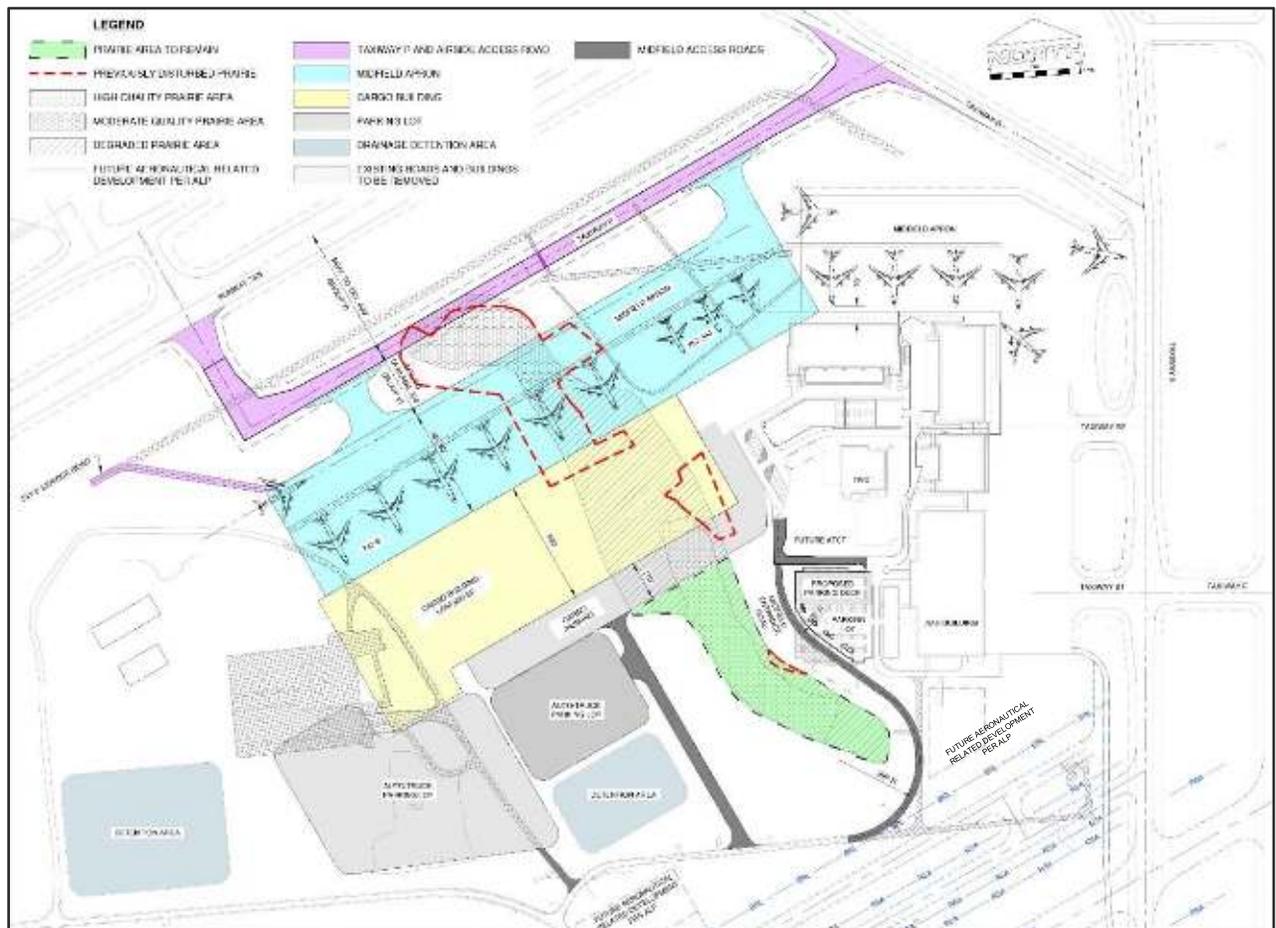
FIGURE 8 – ALTERNATIVE 5: SOUTHEASTERN ACCESS ROAD ALIGNMENT

Under this alternative, the southern termination point would connect to the existing roadway at a location that utilizes more of the existing roadway. The vertical grade differences dictate the connection point to maintain a feasible longitudinal grade to accommodate truck traffic. The alignment still requires a reverse curve but will eliminate the one of the three curves used in Alternative 4. The second curve would have a radius of 355' and would require the use of maximum superelevation to accommodate the geometric alignment. The IDOT BLRS Design Manual recommends avoidance of maximum superelevation in areas subject to ice and snow. The City of Rockford, Illinois averages 35 inches of snow per year.

The addition of curves results in a less safe roadway compared to the Action. The safety performance evaluated using IHSDM indicated that this roadway alignment would be expected to result in approximately 15.7 crashes within the 20 year design horizon (see Appendix D).

Similar to Alternative 4, implementation of this alternative would also impact the utilities and MRO facility parking lot. This alternative would impact 8.7 acres of prairie (1.1 acres high quality, 0.7 acres moderate and 6.9 acres degraded prairie) and would include the retention of 6.7 acres of prairie, including and 4 acres of high quality prairie and 2.7 acres of degraded prairie.

This alternative meets the project purpose and need. Due to the decreased safety performance of the roadway and the use of the maximum superelevation, which is not recommended by the IDOT BLRS Design Manual, this alternative is not prudent and was not selected.

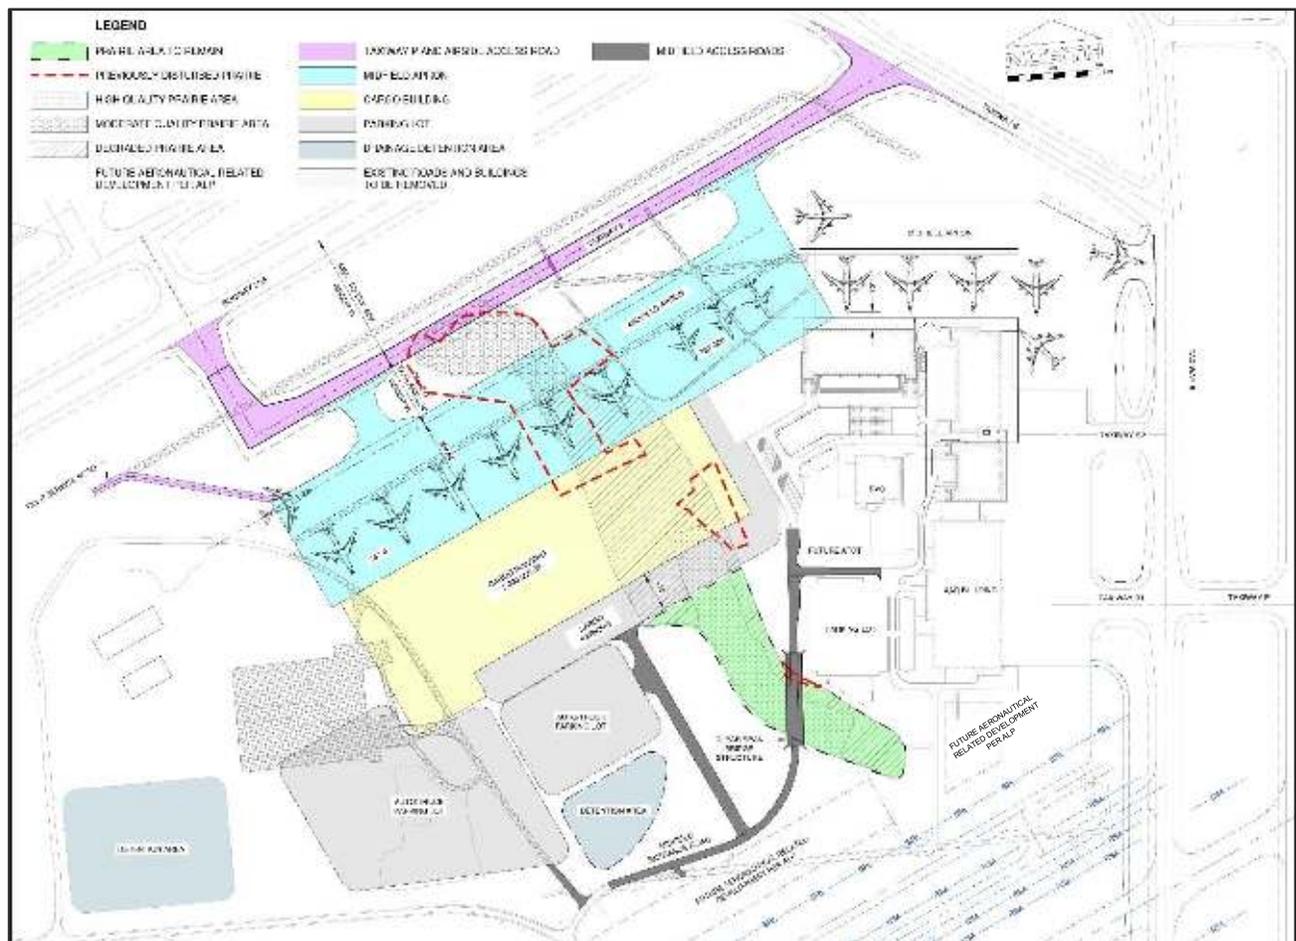
FIGURE 9 – ALTERNATIVE 6: BRIDGE ALIGNMENT

This roadway design utilizes the preferred roadway alignment from Cessna Road to the primary Cargo Building complex but utilizes a bridge over the existing prairie area to avoid direct destruction of the prairie substrate from the placement of the roadway. The concept would entail a one-span bridge over the entire prairie resulting in a span length of approximately 280 feet. To span this distance, a steel girder would need to be approximately 10 feet tall. The roadway profile would need to be raised approximately 15 to 20 feet to create space between the bottom of the bridge girder and the existing ground. Significant embankment fill would be needed on each end of the bridge to create the profile needed at the bridge while also providing a reasonable longitudinal grade for trucks to

climb the hill. The safety performance evaluated using IHSDM indicated that this roadway alignment would be expected to result in approximately 7.5 crashes within the 20 year design horizon (see Appendix D).

This alternative would result in a total of 8.7 acres of direct prairie impact (1.1 acres high quality, 0.7 moderate quality and 6.9 acres degraded) and would include the retention of 6.7 acres of prairie, including 4 acres of high quality and 2.7 acres of degraded prairie. While the prairie substrate would not directly be impacted by the bridge, shading of the prairie would likely impact the ability of the vegetation to thrive and would limit the prairie function and values for the 0.7 acres underneath the bridge, resulting in an indirect impact of 0.7 acres. Since this alternative only provides the benefit of 0.7 acres of direct impact on the prairie substrate, but would provide a less safe roadway, this alternative is not prudent and was not selected.

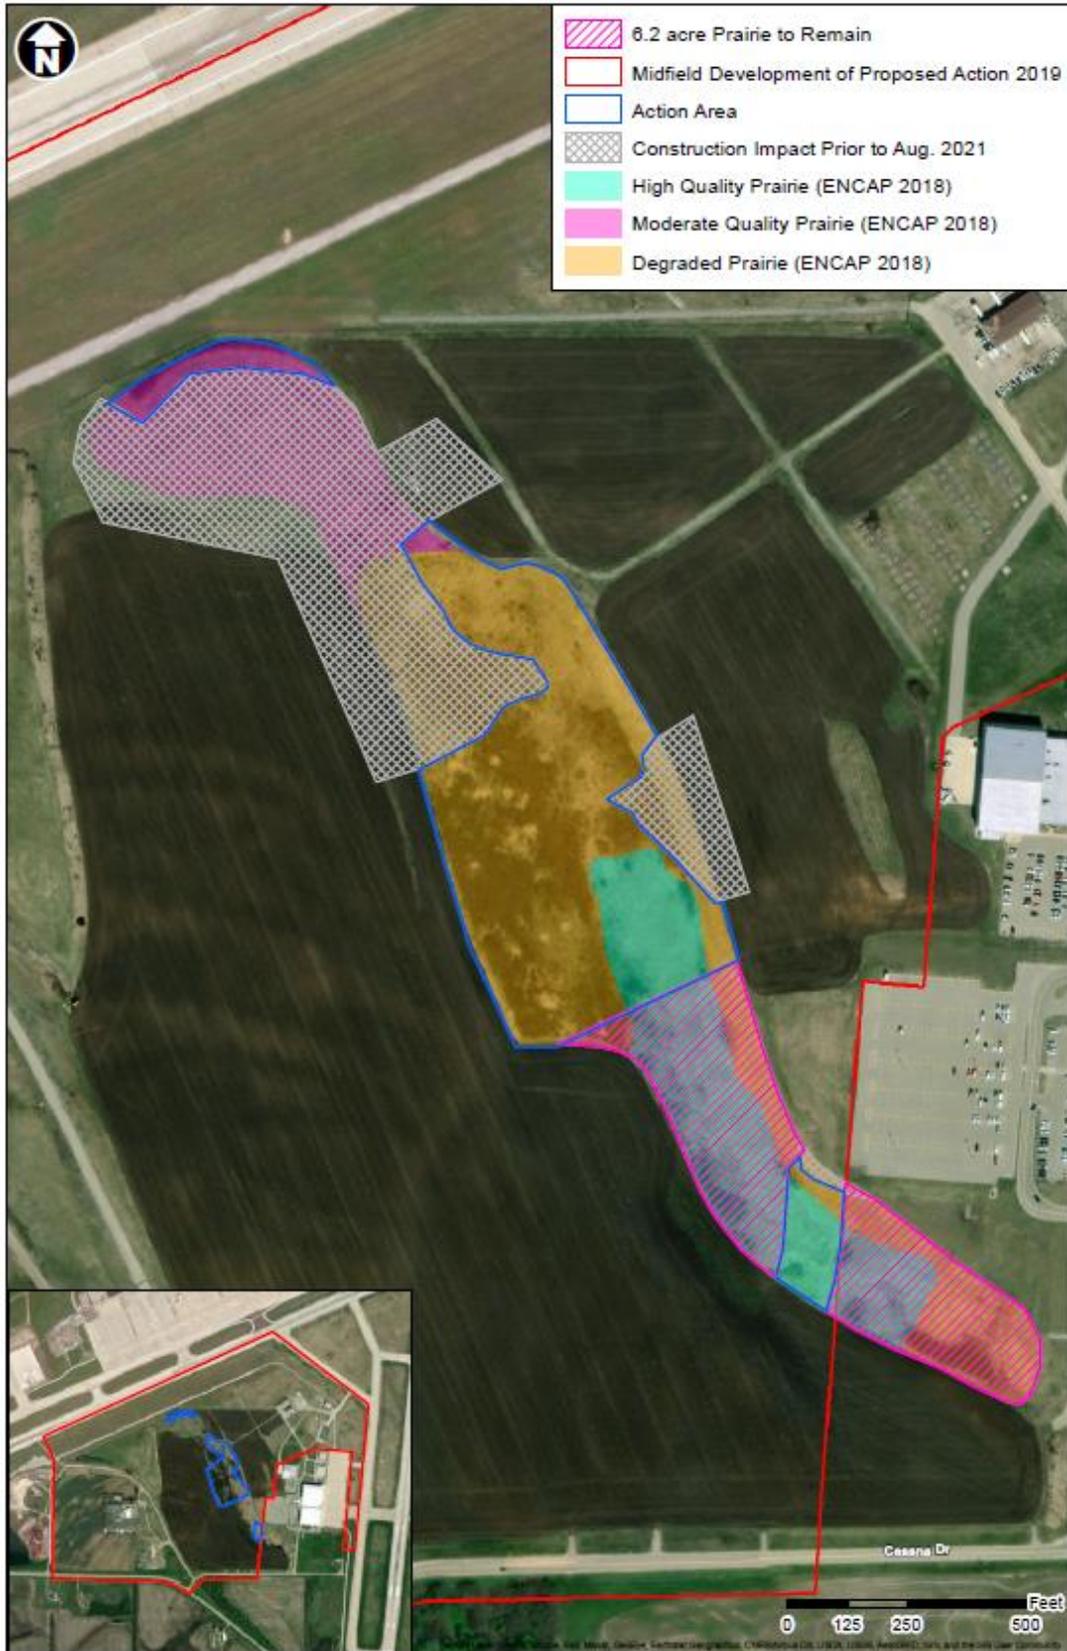
FIGURE 9 – 6.2 ACRE REMAINING PRAIRIE

Approximately 4.3 acres of suitable nesting habitat will remain within the 6.2 acre remaining prairie, with all of the acreage being suitable for foraging. The 6.2 acre remaining prairie will not be temporarily or permanently impacted by the Action or disturbed by construction equipment. The predicted overall rusty patched bumble bee habitat score after project completion would be 96 out of 215 for this area, a 22-point reduction from the current conditions score (CMT 2021). The 6.2 acre area of the prairie to remain after the Action is shown on Figure 9.
